INVESTIGATION OF SLIP RING
ASSEMBLIES

INVESTIGATION OF SLIP RING ASSEMBLIES

5 March 1964 to 5 May 1965

Contract No. NAS8-5251
Control No. TP3-83367 (1F)
IITRI Project E6000

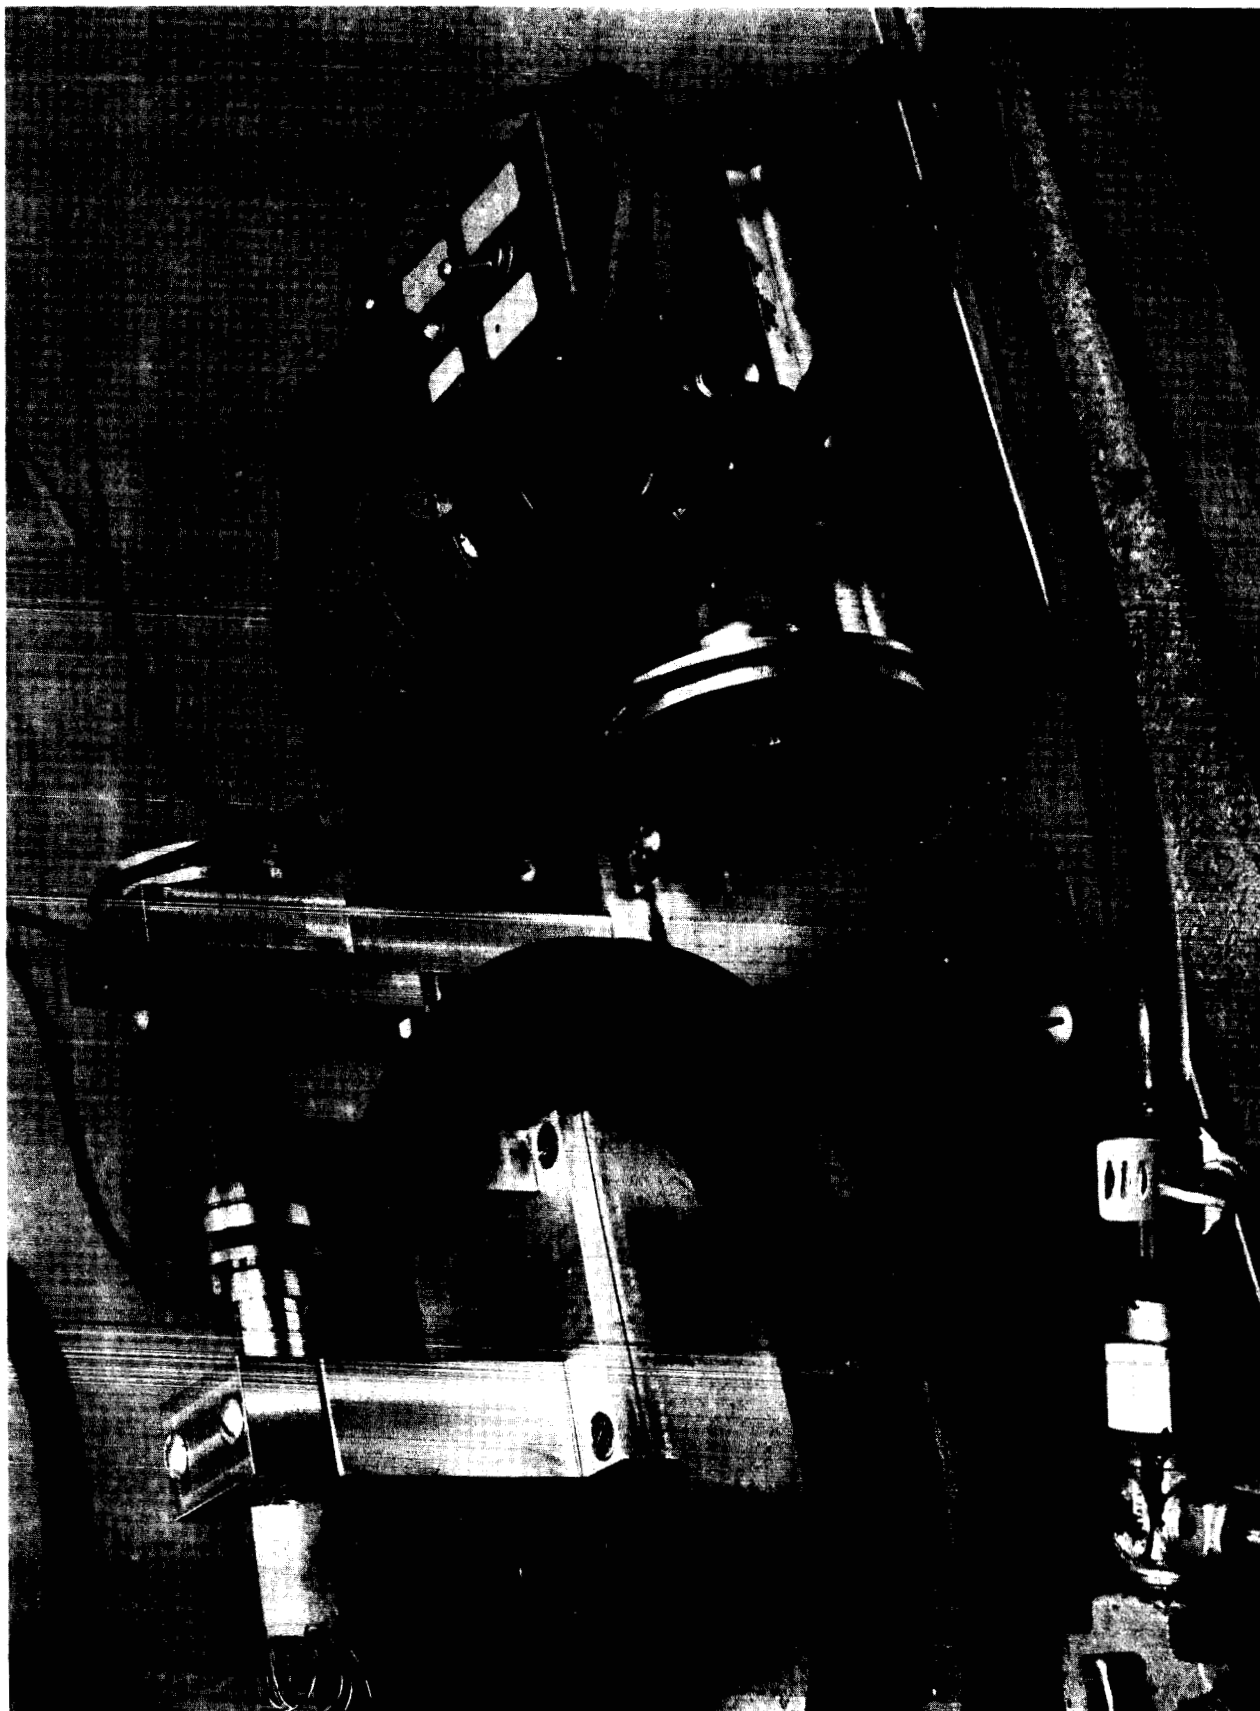
FIGURE 15 CAPSULE DRIVE SYSTEM USED DURING VACUUM TESTS

A close-up of the drive system is shown in Figure 15. Instrumentation used in continuous rotation run-ins in nitrogen atmosphere was also employed for vacuum tests. The capsules were rotated at 200 rpm with a 25 ma brush current. Vacuum obtained in the initial test was 200 microns. Some refinements in the pumping system lowered the vacuum used during subsequent tests to 25 microns.
